Midvale Irrigation District

Wyoming Canal 37.2 Check Structure Replacement

2014 ANNUAL REPORT

Midvale Irrigation District 2014 Annual Report

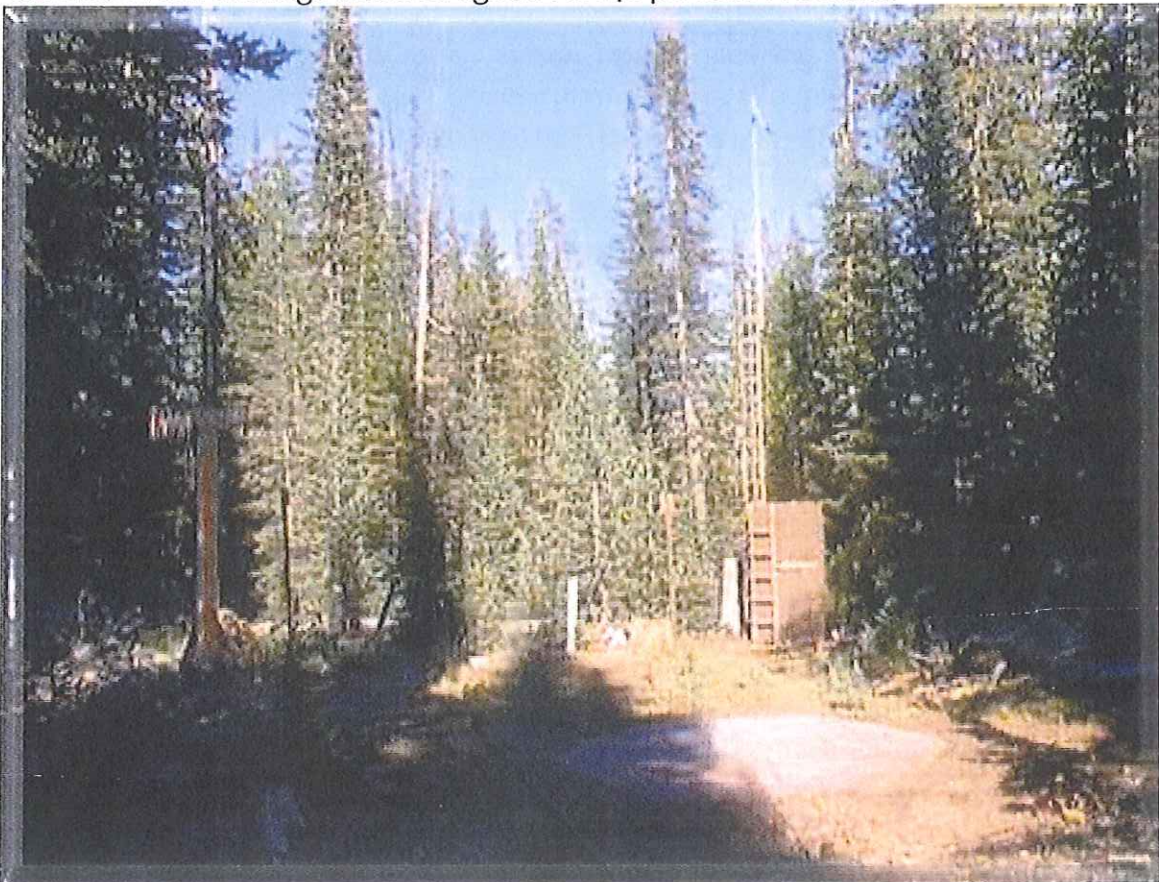
RECONSTRUCTED BURROUGHS CREEK SNOTEL INSTRUMENTATION SITE

A snotel site very valuable to Midvale for water prediction is Burroughs Creek. This site was destroyed during a forest fire in 2013. Because of access and other issues, this site could not be reconstructed until the summer of 2014. Consequently, the state engineer's office was left to collect snowpack data the old fashion way (travel to the site on snow machines and hand measure snow depth). Information obtained from snotel sites is vital to Midvale's ability to make predictions and plan for the water year. We appreciate the efforts of the state engineer's Riverton office for their efforts to provide us with the information we need under challenging circumstances.

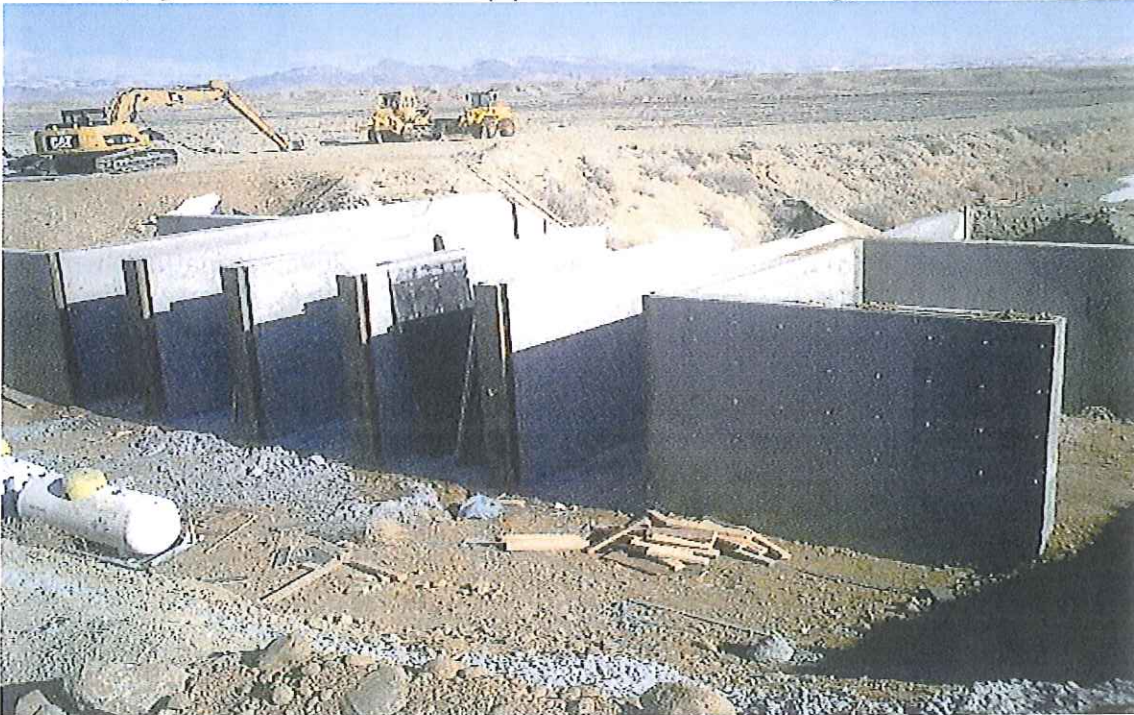
WYOMING 37.2 CHECK STRUCTURE REPLACEMENT:

This year's project is the first phase of a two-phase project to replace two failing concrete structures on the Wyoming Canal. The upper check structure was replaced this winter and will be temporarily connected to the existing chute until the interconnecting pipe and bottom energy dissipating structure can be completed over the winter of 2015-2016. Terry Zenk P.E. of Apex Surveying Inc. designed a combined check/drop structure replacement of a failing upper concrete check and lower concrete drop structures. The project, when completed, will consist of a new check structure, 830 ft. of 60 in. dia. PVC pipe and a concrete energy dissipater structure.

The project application was submitted to the W.W.D.C. in November of 2012 and received funding of \$317,400 at the 2013 legislative session. The original intent was to construct the project in one phase, but when the project was bid in July 2014, pipe suppliers could not provide a bid for the 60 inch diameter PVC pipe. Midvale was informed that a “manufacturing problem” had come up which resulted in the unavailability of the 60 inch diameter pipe. The only other pipe alternative which was suitable for this drop application was High Density Polypropylene (HDPE); however, the bid price Midvale received for this pipe was too expensive for the allocated budget. Consequently, Midvale submitted an application to WWDC in 2014 for an additional budget of \$63,600 and will rebid the pipe in 2015. Midvale expects to have this project completed in time for the 2016 irrigation season.

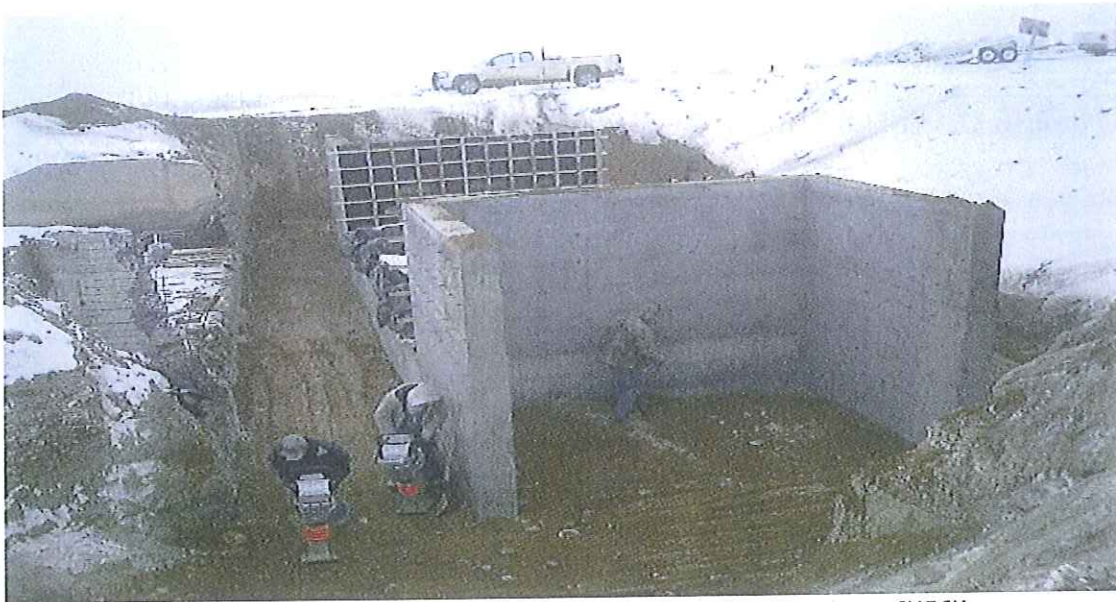
MIDVALE CREW COMPACTING BACKFILL AROUND NEW WC 37.2 CHECK

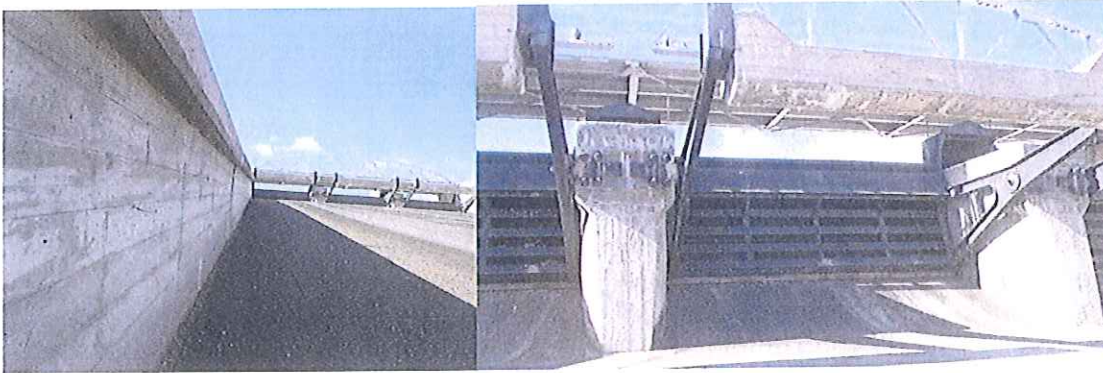
The emergency spillway at Bull Lake is a 100-foot wide concrete chute structure with three 29' long by 12' high radial gates equipped with concrete encased counterweights.

Voids have developed beneath the spillway chute floor slabs downstream of the crest structure. Freeze-thaw cycles have caused concrete delamination of the chute floor slabs. Additionally, the concrete piers that support the bridge and radial gates have developed significant cracking, resulting from alkali-aggregate reaction and freeze-thaw damage. The deterioration of these supports has raised concerns about the potential risk of failure of the radial gates. Lateral movement of the chute walls has limited the full range of gate movement and compromised the ability of the gates to operate properly as designed.

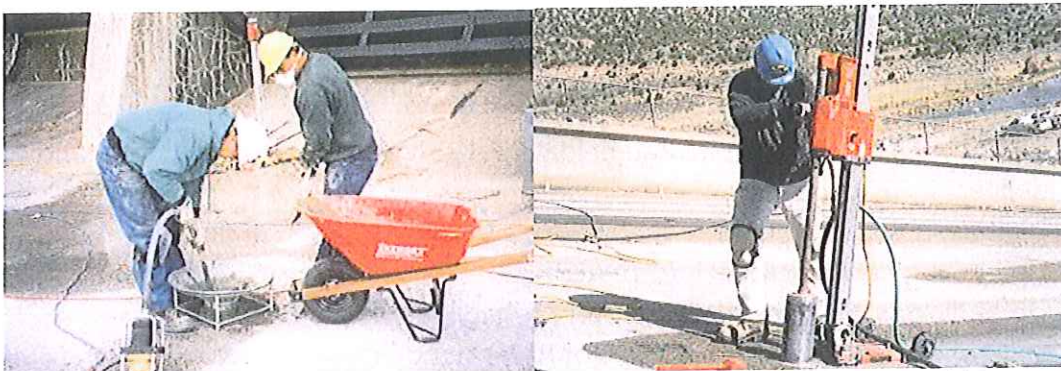
MIDVALE CREWS PERFORMING INTERIM REPAIRS AND CORING ON SPILLWAY SLAB
